### RESEARCH REPORT

# EVALUATION OF INTELLIGENT TRANSPORTATION SYSTEM DEPLOYMENTS FOR WORK ZONE OPERATIONS

MD-05-SP208B4H  
FINAL REPORT

AUGUST 2005

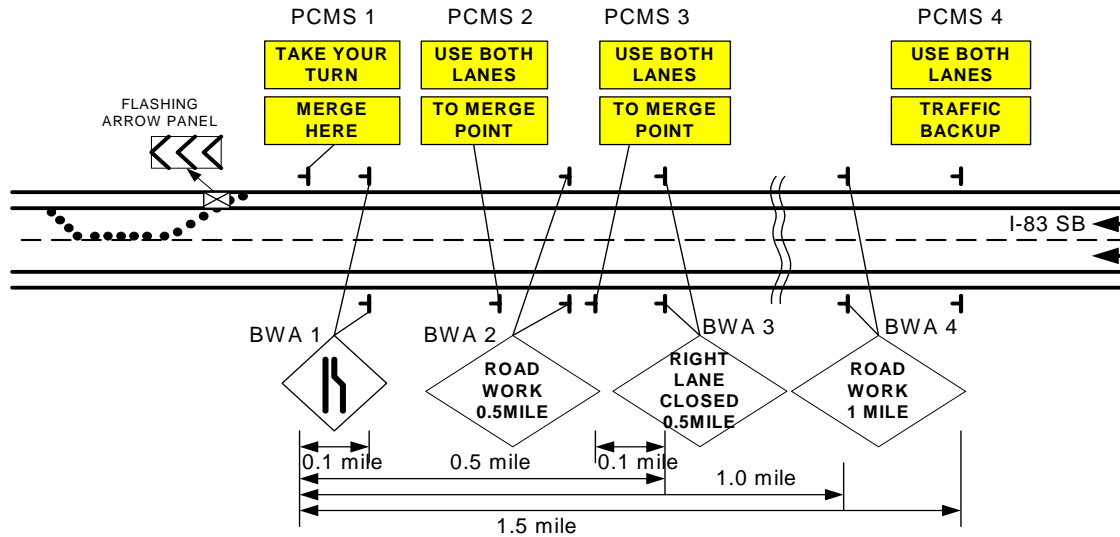
**Figure 0-1:** Configuration of the DLM system

A Dynamic Late Merge system generally consists of a series of variable message signs that will be activated or deactivated based on real-time measurements of traffic conditions.

Dynamic Late Merge (referred to as DLM), as shown in Figure 1-1, is designed to provide safe merging operations under congested traffic conditions. It has the following key system features:

- Using PCMS (Portable Changeable Message Signs) to display messages to motorists when the DLM system is active (i.e., “USE BOTH LANES” and “TO MERGE POINT”);
- Employing traffic sensors such as RTMS (Remote Traffic Microwave Sensor), placed at the same locations as PCMS 1, 2 and 3 for detecting traffic conditions in real time;
- It is generally operated alone with static warning signs (i.e., BWA 1, 2, 3 and 4), which are similar to those used in conventional work zone control (referred to as No-control) proposed by NDOR (Nebraska Department of Roads) for informing approaching motorists of the lane closure when the DLM system is not active.

However, during field observations, it has been observed that many drivers decided to merge at the locations of the static merge signs (i.e., lane-reduction-symbol and advance lane-closed sign, see BWA 1 and 3 in Figure 1-1) instead of traveling all the way to the first PCMS location. The confusion of these drivers caused by the concurrent presence of the static merge sign and the PCMS message often resulted in multiple merge points along the work zone, and the under utilization of the closed lane.

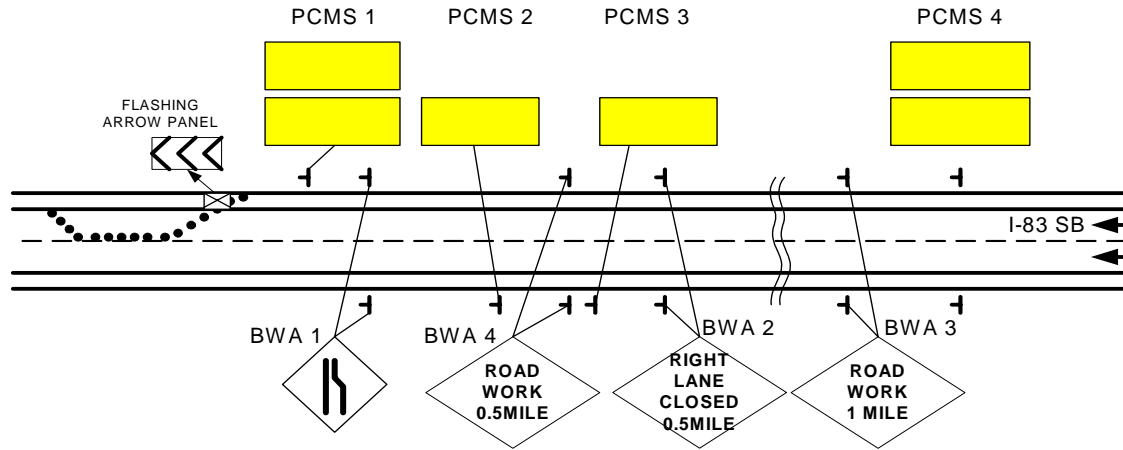
Figure

0-3: System deactivation under free flow traffic conditions

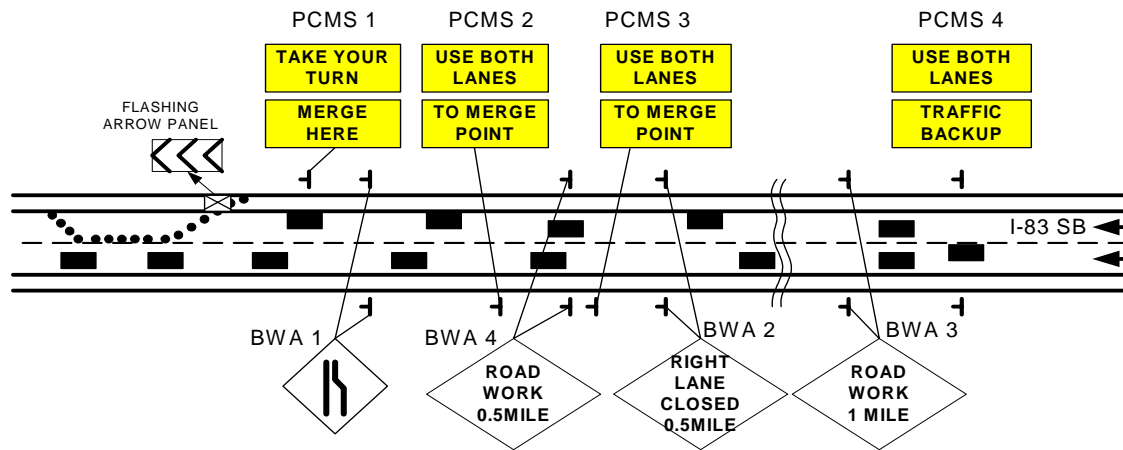
Figure

0-4: System activation under congested flow traffic conditions

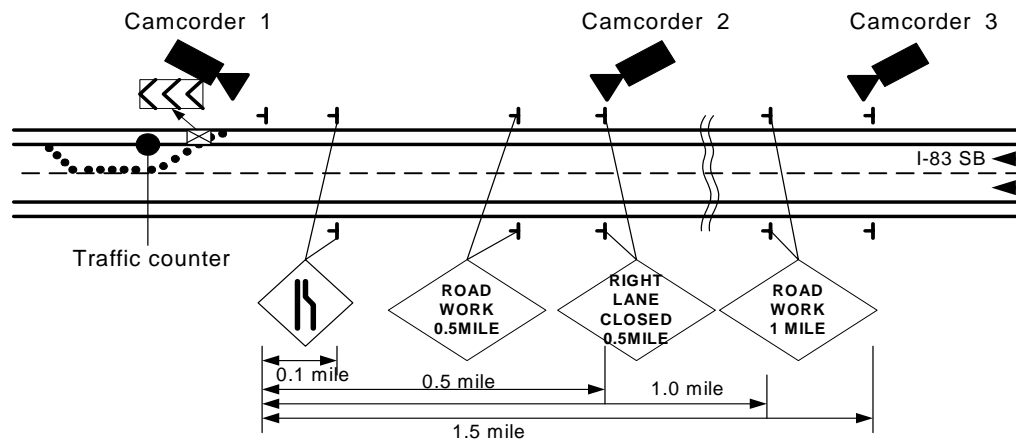
Field data for evaluation was gathered with three camcorders (see Figure 2-1 for camcorder locations) and focused on capturing volume data, merge behavior, traffic conflicts, and queue lengths. In addition, two speed guns were used to measure the distribution of spot speeds. The camcorders were installed at the merge point (i.e., Camcorder 1 and PCMS 1) close to the beginning of the taper, at the middle point (i.e., Camcorder 2 and PCMS 3) about 0.5 mile before the taper, and at the upstream point (i.e., Camcorder 3 and PCMS 4) about 1.5 miles away from the lane closure location (also see Figure 1-1). Speed samples were collected at the merge and middle points. The data collection plan is summarized in Table 2-1. Traffic flow data such as volume, speed, and occupancy were also available from RTMS for system performance evaluation under the DLM control.

**Figure 0-1:** Locations of the camcorders

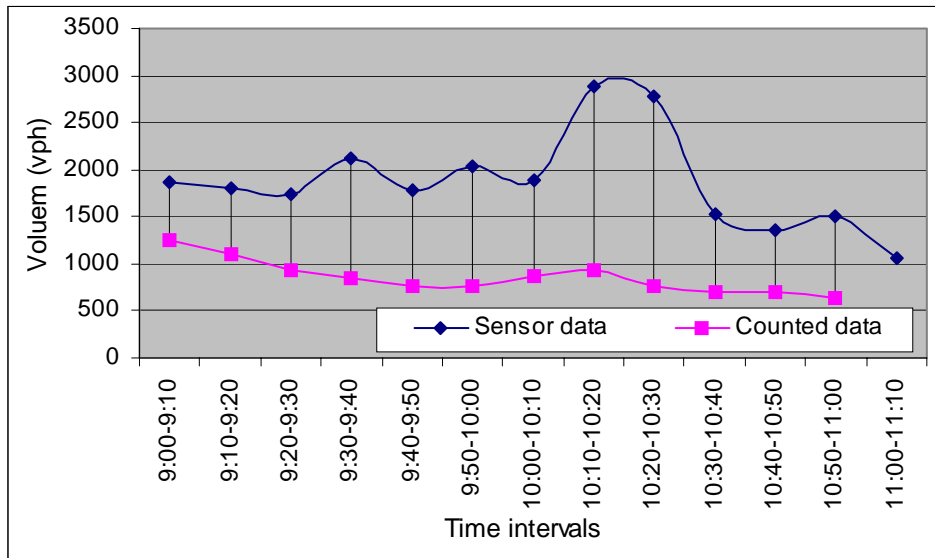
**Figure 0-4:** Comparison of volume data on the open lane (Middle point, 10/22/2003)

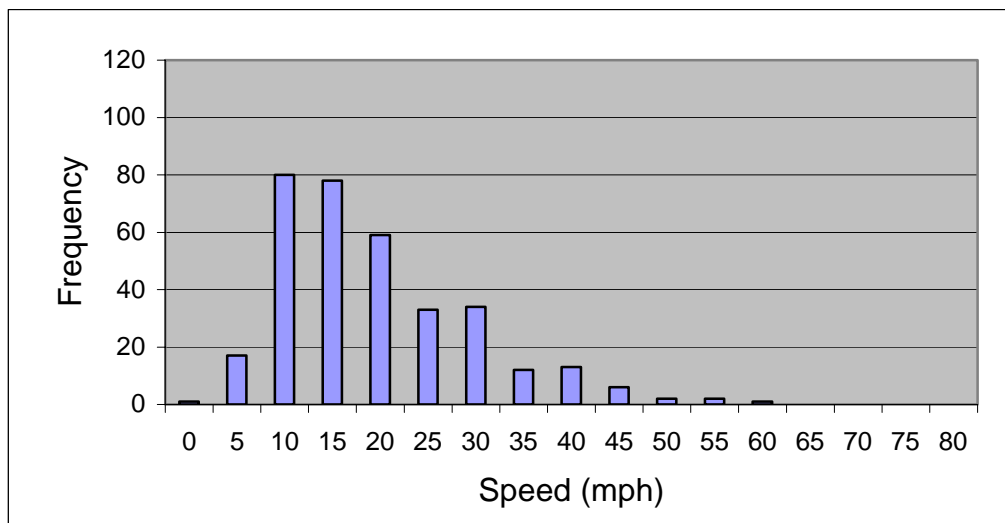
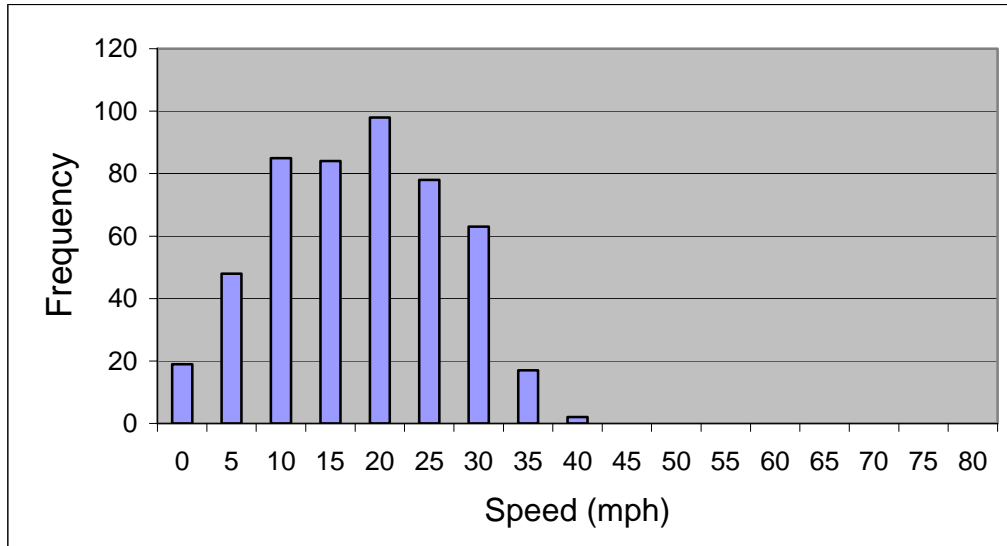
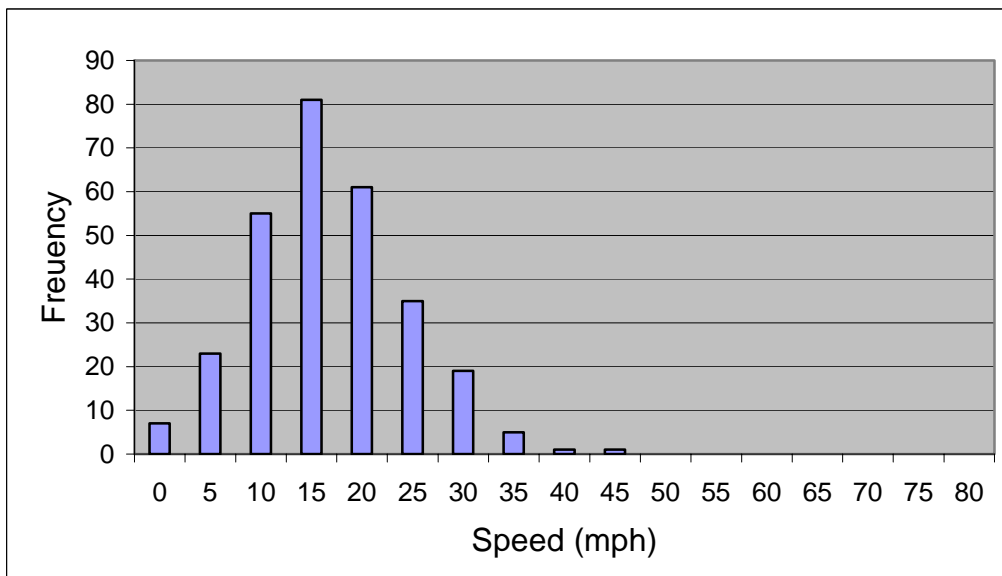
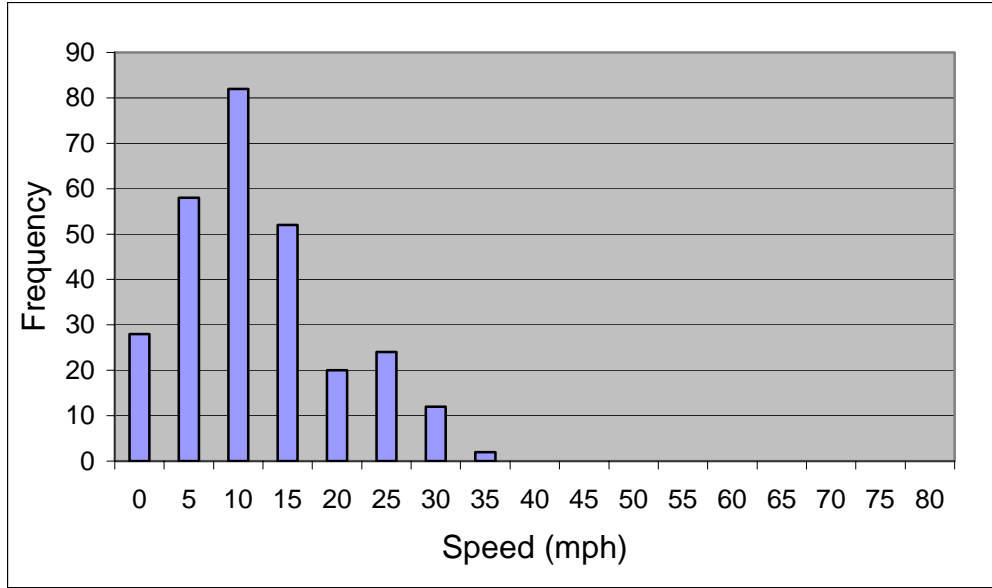
Figures 3-5 to 3-12, respectively, present the distributions of speed on the open and closed lanes under No-control and DLM control. It should be noted that the speed distributions on 10/10/2004 were measured with speed guns, and the distribution on all other dates were based on data measured by RTMS.

**Figure 0-5:** Speed distribution on the closed lane (Merge point, 10/10/2003)

**Figure 0-6:** Speed distribution on the open lane (Merge point, 10/10/2003)

**Figure 0-7:** Speed distribution on the closed lane (Middle point, 10/10/2003)

**Figure 0-8:** Speed distribution on the open lane (Middle point, 10/10/2003)

Based on the speed distributions measured under No-control (i.e., Figures 3-5 to 3-8) and field observations, it is apparent that the RTMS sensors under DLM control did not provide accurate speed measurements (Figures 3-9 to 3-12). For example, it is unlikely that some speeds have exceeded 100 mph on the open lane at the merge point (see Figure 3-10), during the DLM control period.

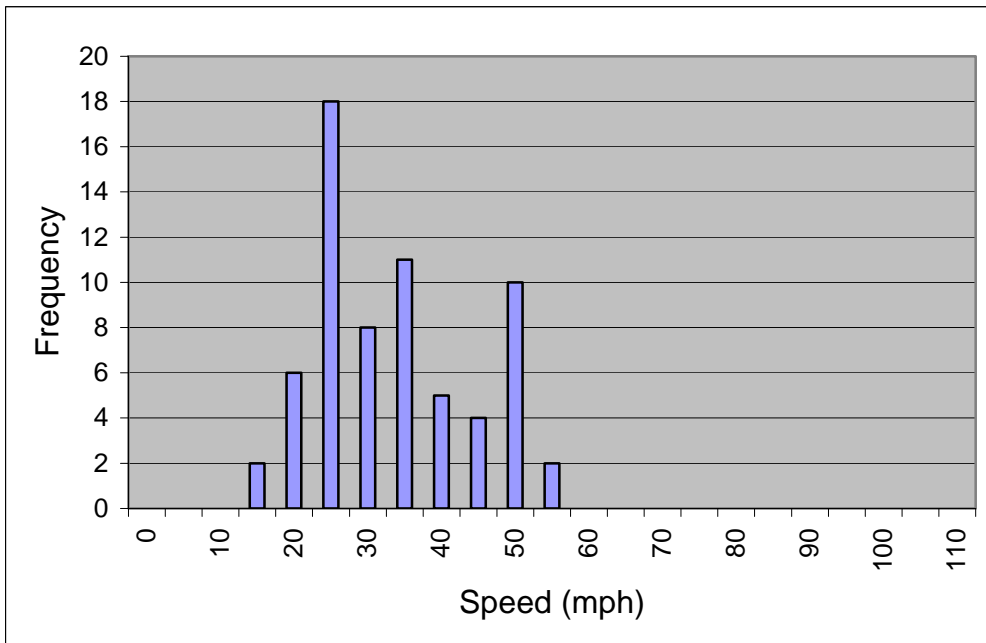
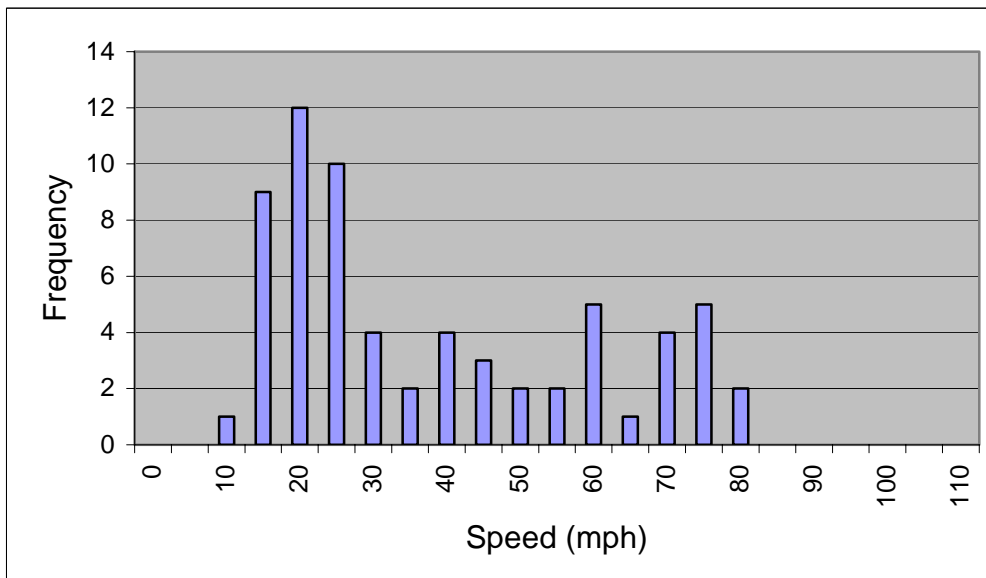
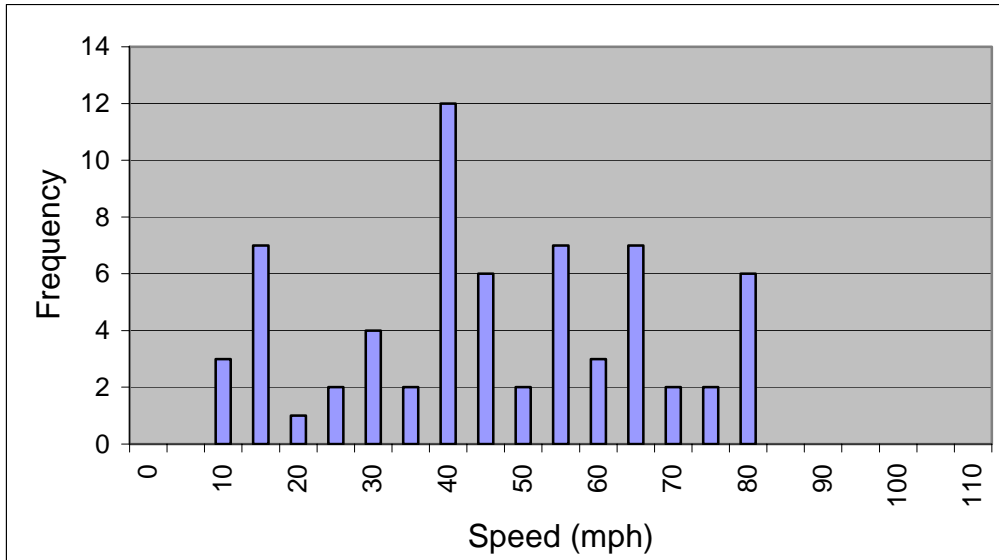
**Figure 0-9:** Speed distribution on the closed lane (Merge point, 10/23/2003)

**Figure 0-10:** Speed distribution on the open lane (Merge point, 10/23/2003)

**Figure 0-11:** Speed distribution on the closed lane (Middle point, 10/23/2003)

**Figure 0-12:** Speed distribution on the open lane (Middle point, 10/23/2003)

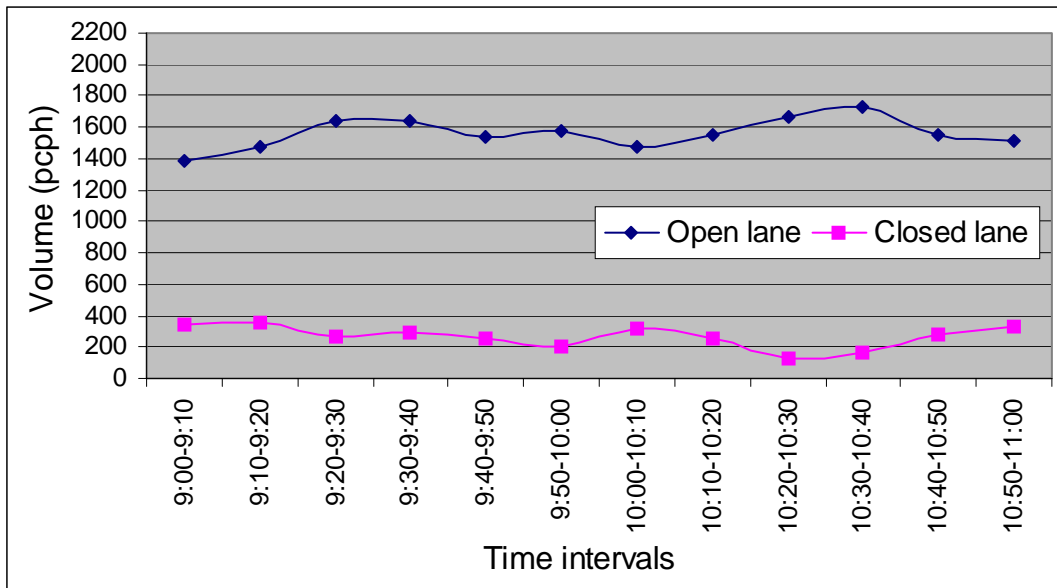
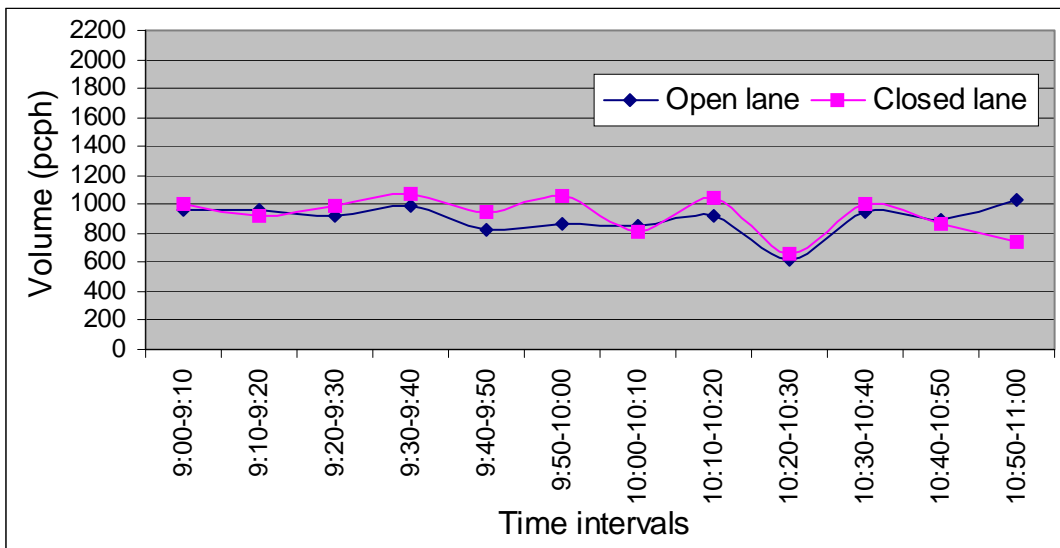
Figures 4-1 to 4-3 display the lane volume distributions at the merge, middle, and upstream points, respectively, under the No-control operation. Note that although volumes were nearly equal between both lanes at the upstream point (see Figure 4-3), many drivers began to use the open lane when they reached the middle point (see Figure 4-2). Also note that a large number of vehicles were observed on the open lane at the merge point (see Figure 4-1).

**Figure 0-1:** Lane volume distribution at the merge point (No-control, 10/10/2004)

**Figure 0-2:** Lane volume distribution at the middle point (No-control, 10/10/2004)

**Figure 0-3:** Lane volume distribution at the upstream point (No-control, 10/10/2004)

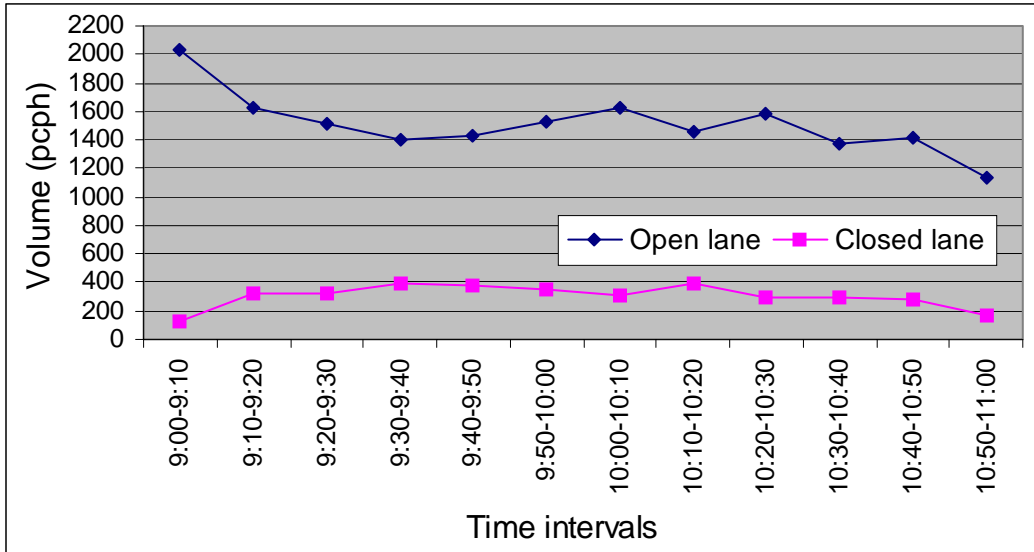
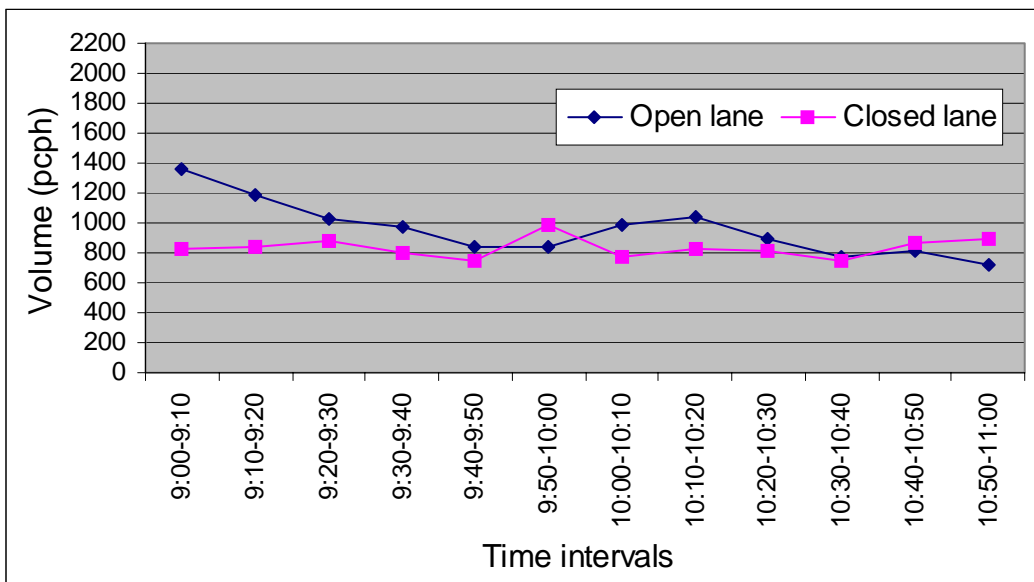
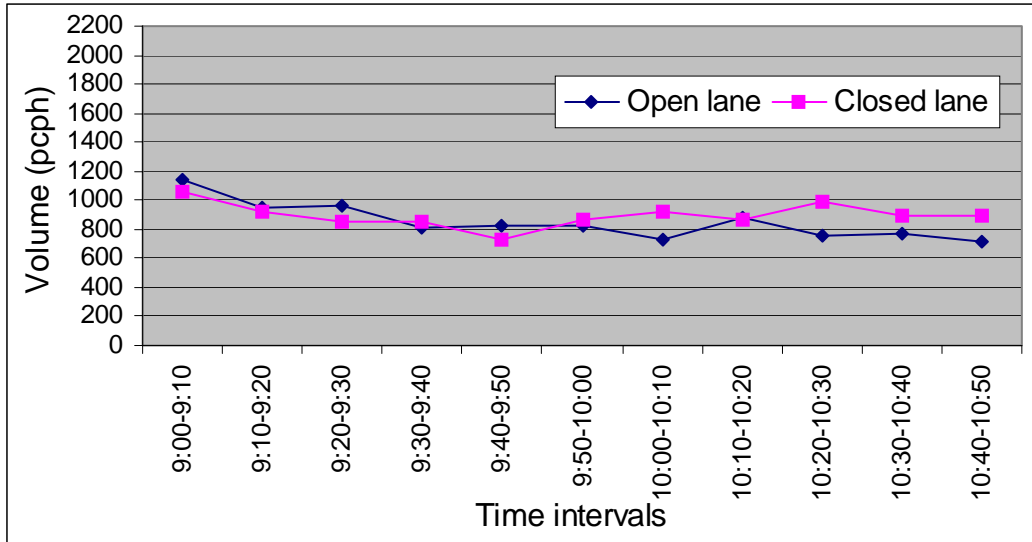
Figures 4-4 to 4-6 illustrate the lane volume distributions at the merge, middle, and upstream points, respectively, under DLM control. Though their patterns are similar to those under the No-control operation, it is notable that the distribution of volume under DLM control between the open and closed lanes at the middle point was quite uniform. This means that drivers indeed followed the messages (i.e., “USE BOTH LANES TO MERGE POINT”) displayed on PCMS 3 (see Figure 1-1) when the DLM system was activated under these congested traffic conditions.

**Figure 0-4:** Lane volume distribution at the merge point (DLM control, 10/23/2004)

**Figure 0-5:** Lane volume distribution at the middle point (DLM control, 10/23/2004)

**Figure 0-6:** Lane volume distribution at the upstream point (DLM control, 10/23/2004)

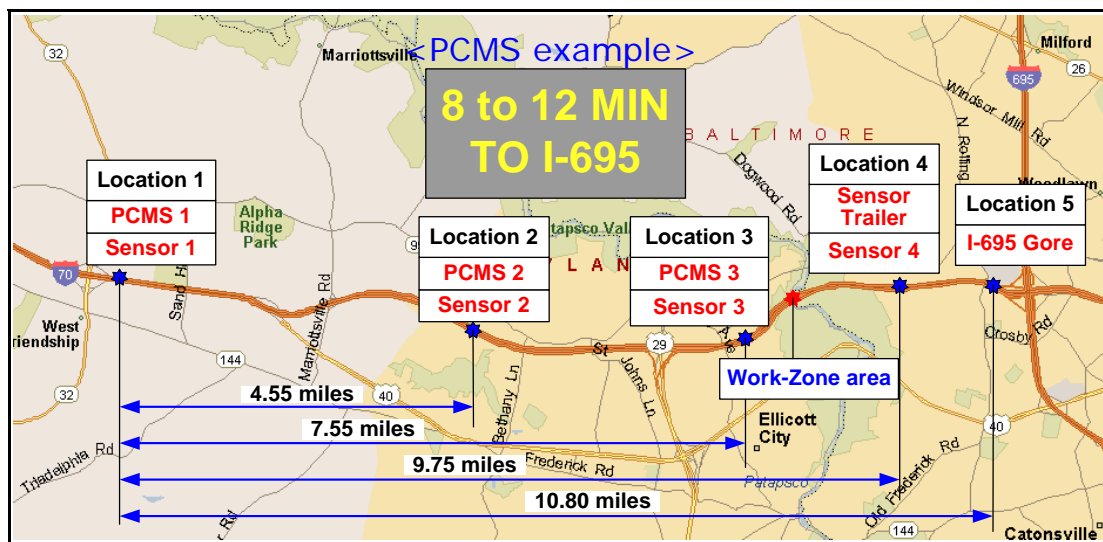
As shown in Figure 1-1, the information displayed on each PCMS is a range (e.g., 8 to 12 min to I-695) of expected travel times from each PCMS location to the last target site (i.e., I-695 Gore).

Figure 0-1: TIPS deployment site

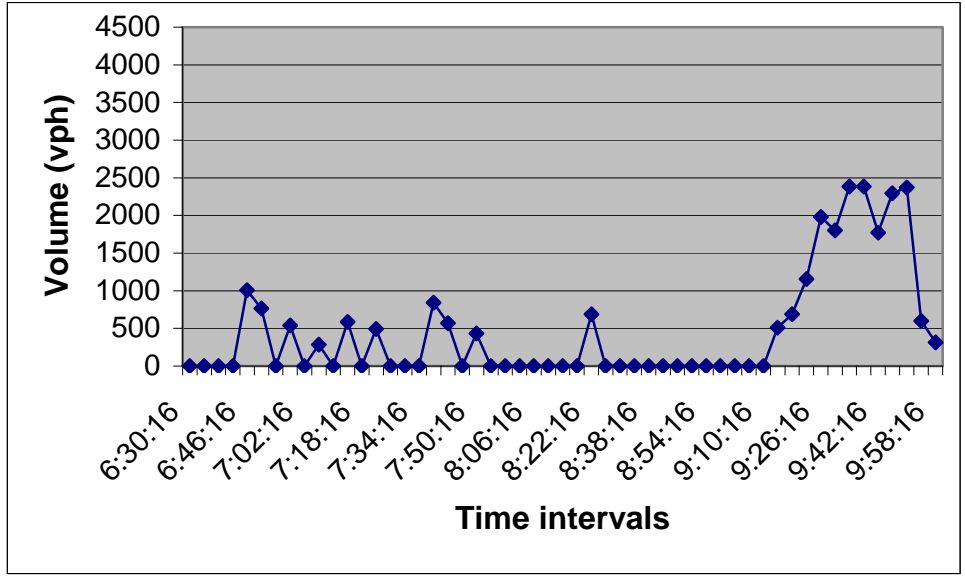
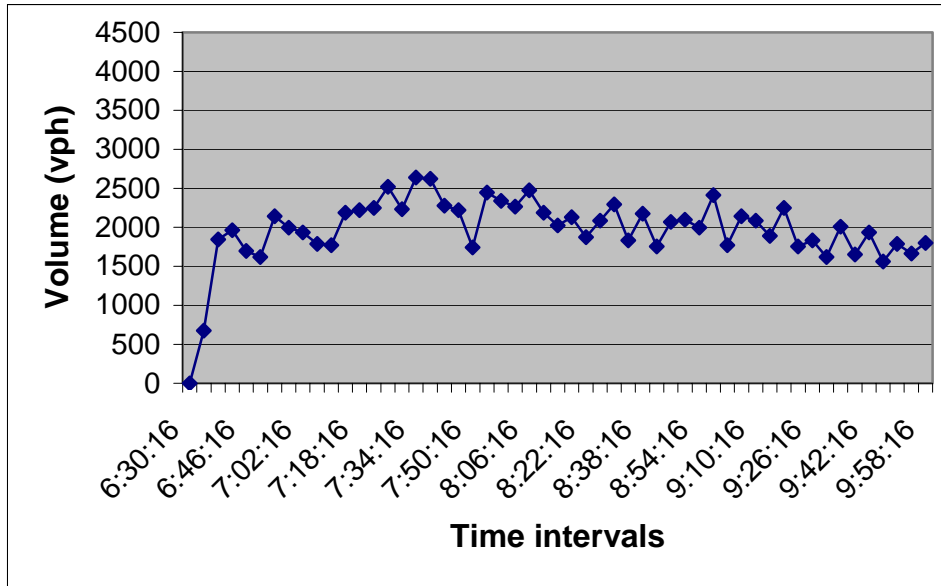
Figures 4-3 to 4-7 present the traffic flow data obtained from the four sensors (i.e., RTMS) in TIPS. It is clear that the first sensor, associated with PCMS #1, did not appear to function properly as evidenced in many of the “zero-flow” intervals.

**Figure 0-3:** Volume distribution from Sensor #1 at PCMS #1 (AM, 11/14/2003)

**Figure 0-4:** Volume distribution from Sensor #2 at PCMS #2 (AM, 11/14/2003)

**Figure 0-5:** Volume distribution from Sensor #3 at PCMS #3 (AM, 11/14/2003)

**Figure 0-6:** Volume distribution from Sensor #4 at Sensor Trailer (AM, 11/14/2003)

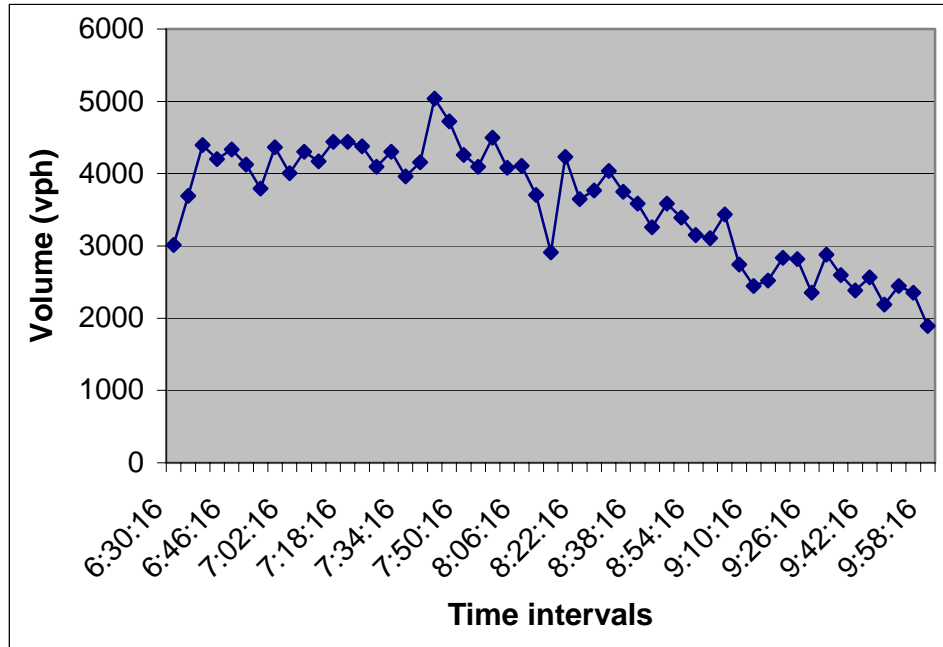
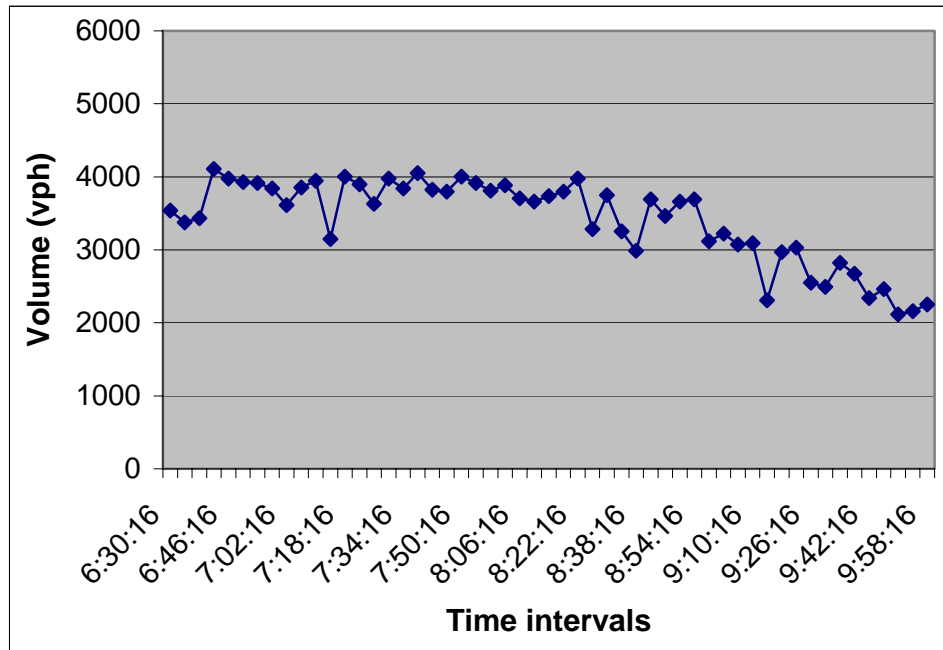
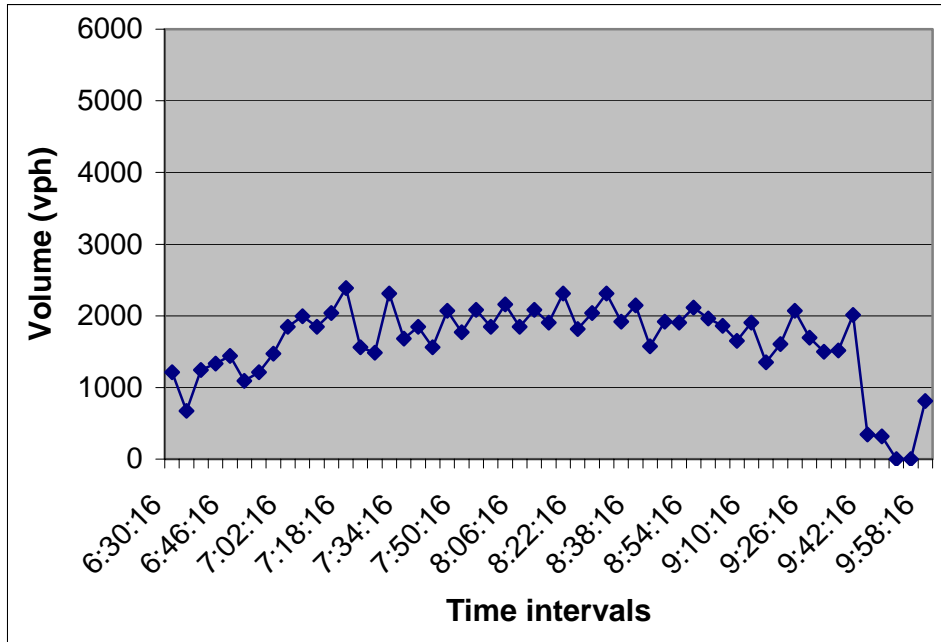
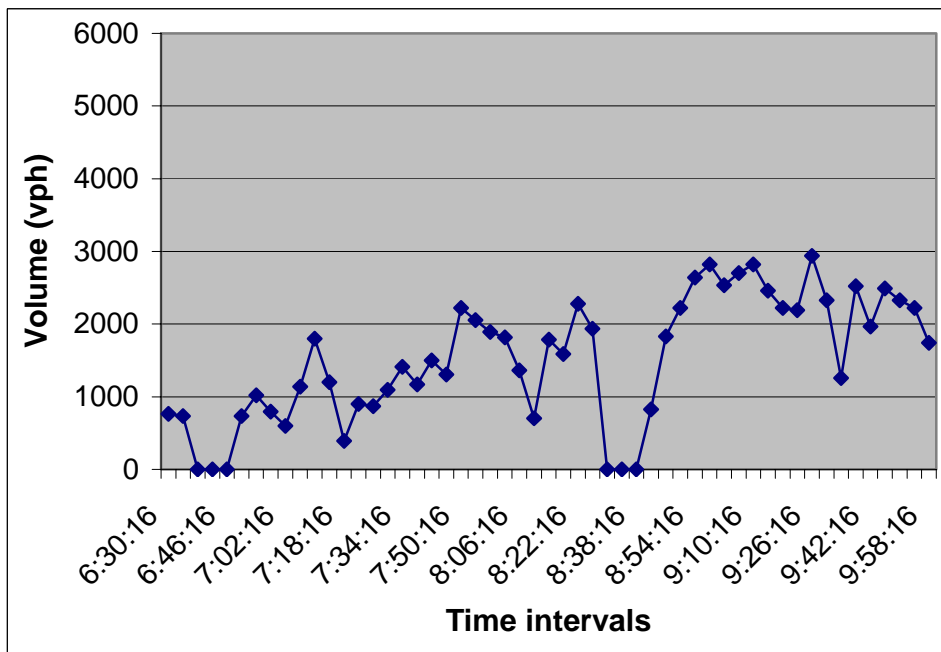
Figures 4-9 to 4-12 present the traffic flow patterns at the locations of the three PCMSs and one Sensor Trailer during the field survey periods (6:30 a.m. ~ 10:00 a.m.). It is noticeable that traffic volume at the location of PCMS #1 decreased abruptly (see Figure 4-9), but exhibited a smooth traffic flow pattern at the locations of PCMS #2 and #3.

**Figure 0-9:** Volume distribution from Sensor #1 at PCMS #1 (AM, 11/19/2003)

**Figure 0-10:** Volume distribution from Sensor #2 at PCMS #2 (AM, 11/19/2003)

**Figure 0-11:** Volume distribution from Sensor #3 at PCMS #3 (AM, 11/19/2003)

**Figure 0-12:** Volume distribution from Sensor #4 at Sensor Trailer (AM, 11/19/2003)

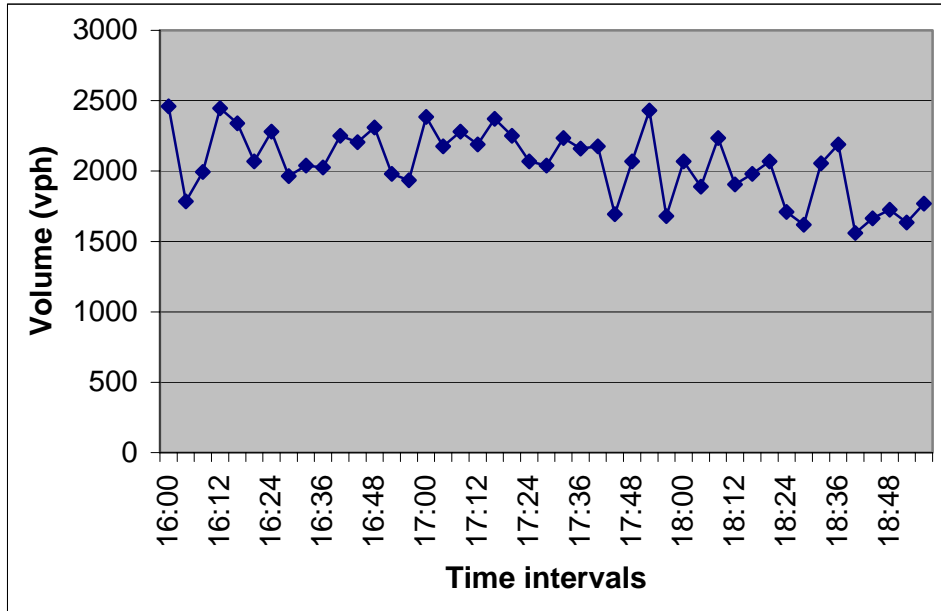
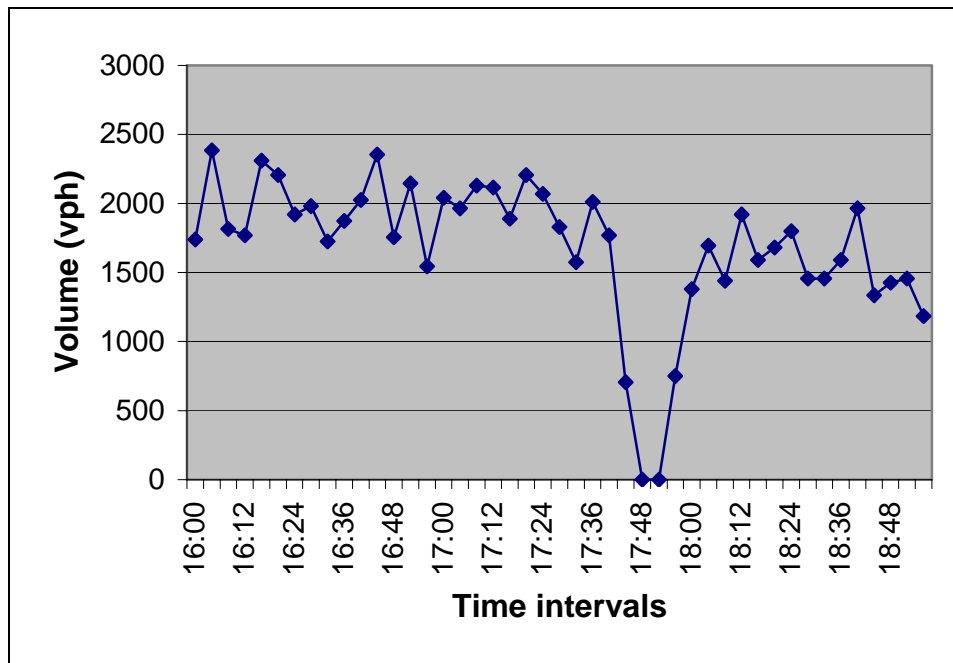
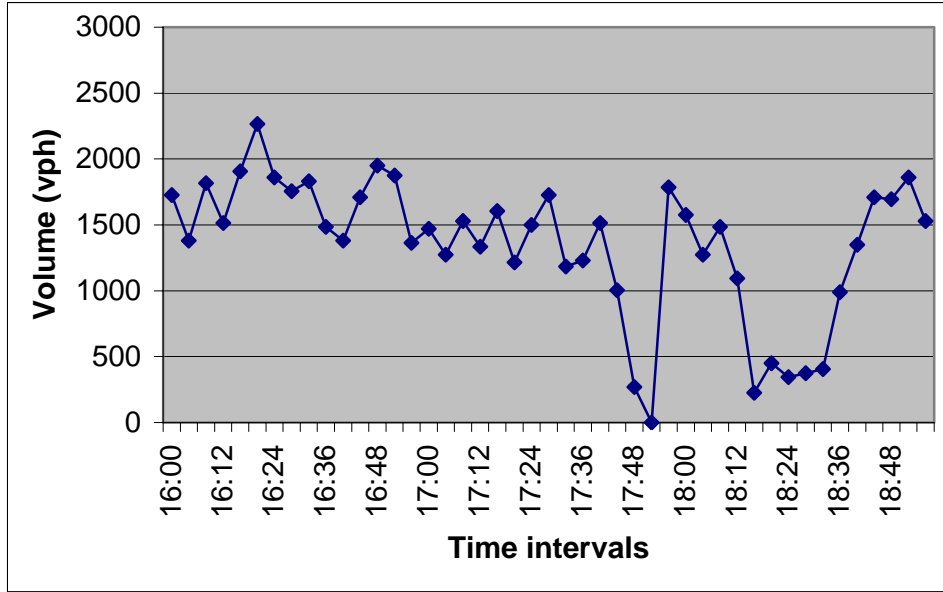
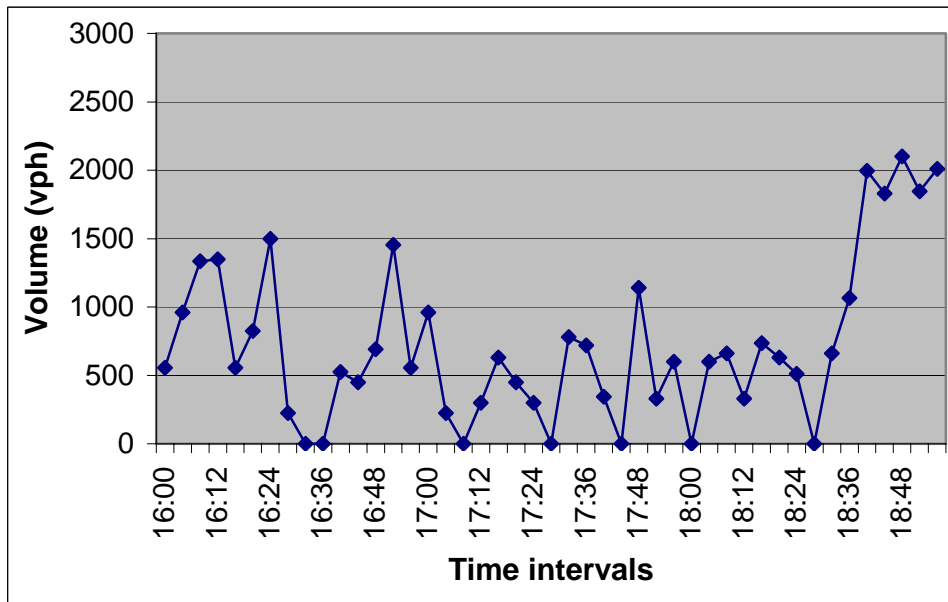
Based on the data obtained from all four sensors, Figures 4-13 to 4-16 present traffic flow patterns during the field survey period (4:00 p.m. ~ 7:00 p.m.). It should be noted that except at the location of the sensor trailer, traffic conditions were quite smooth on the targeted freeway segment. The predicted travel times by TIPS appear to mostly lie within an acceptable range under such traffic conditions.

**Figure 0-13:** Volume distribution from Sensor #1 at PCMS #1 (PM, 11/24/2003)

**Figure 0-14:** Volume distribution from Sensor #2 at PCMS #2 (PM, 11/24/2003)

**Figure 0-15:** Volume distribution from Sensor #3 at PCMS #3 (PM, 11/24/2003)

**Figure 0-16:** Volume distribution from Sensor #4 at Sensor Trailer (PM, 11/24/2003)

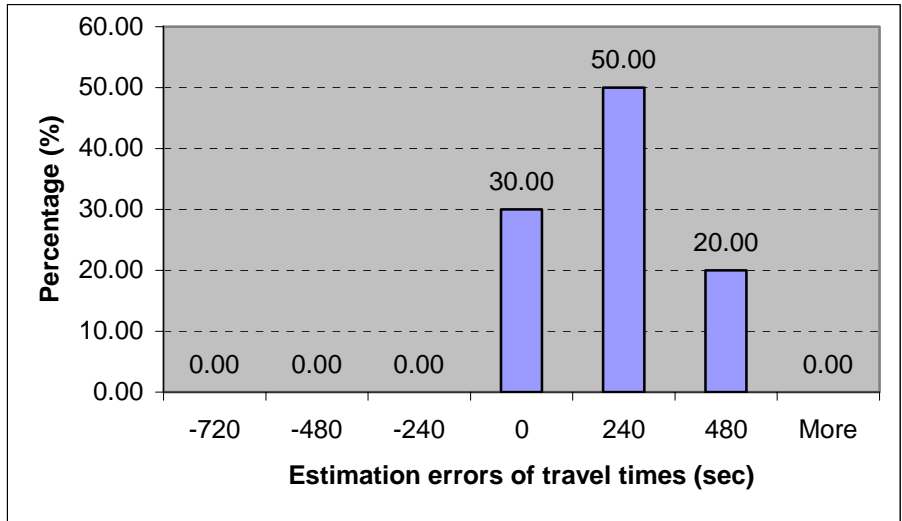
Additional analysis conducted for PCMS #2 also indicates that TIPS tends to underestimate travel time (see Figure 4-19), especially at the beginning and end of congestion periods (see Figure 4-20).

**Figure 0-19:** Distribution of predicted travel time errors at PCMS #2 (AM, 11/25/2003)

**Figure 0-20:** Distribution of incorrect travel times predicted at PCMS #2 (AM, 11/25/2003)

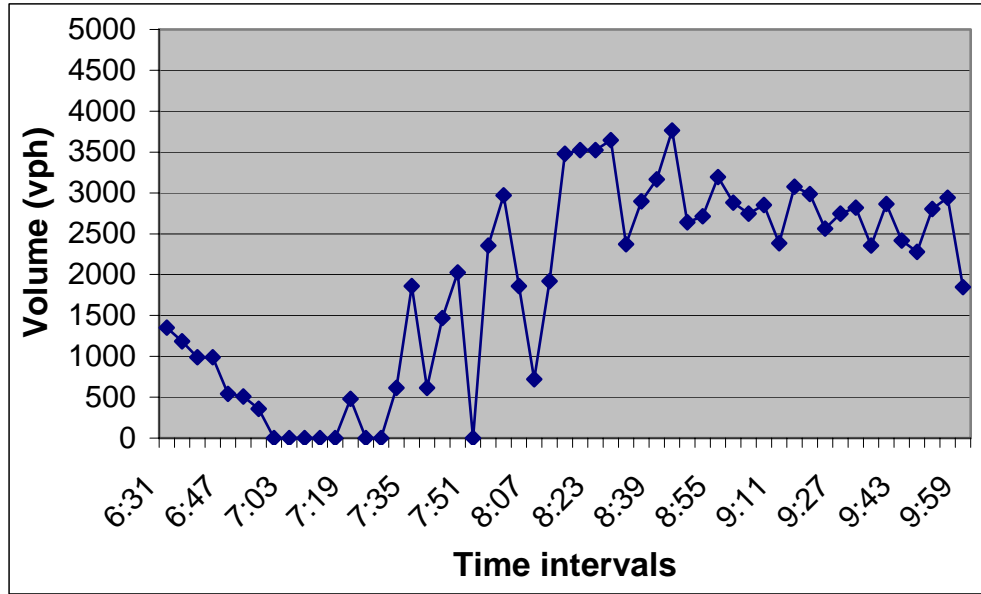
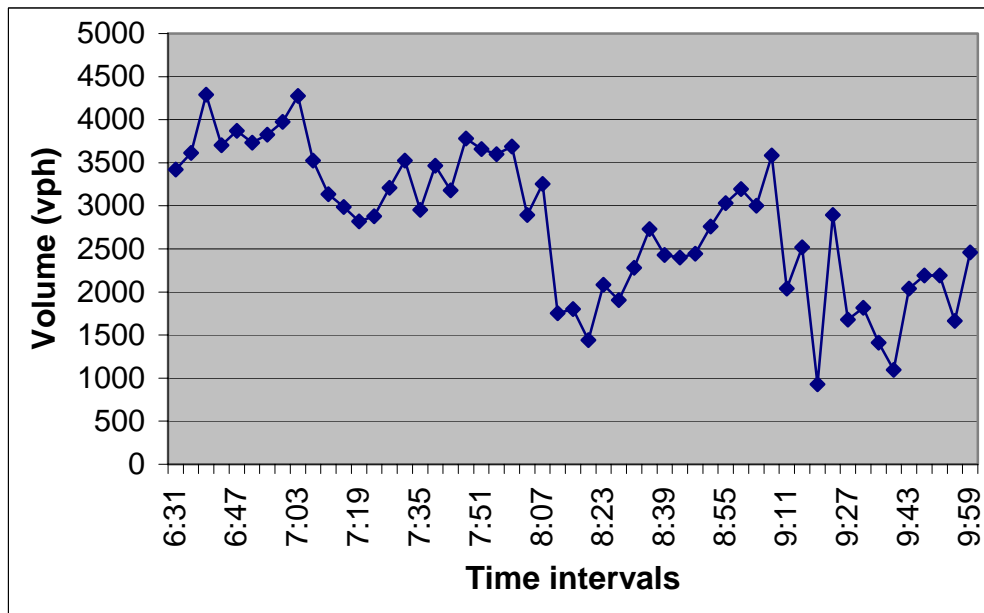
As shown in Table 4-7, traffic volume at the locations of PCMS #1 and #2 fluctuated significantly during the survey period, reflecting the existence of unstable traffic conditions (see Figure 4-21 and 4-22, respectively).

**Figure 0-21:** Volume distribution from Sensor #1 at PCMS #1 (AM, 11/25/2003)

**Figure 0-22:** Volume distribution from Sensor #2 at PCMS #2 (AM, 11/25/2003)

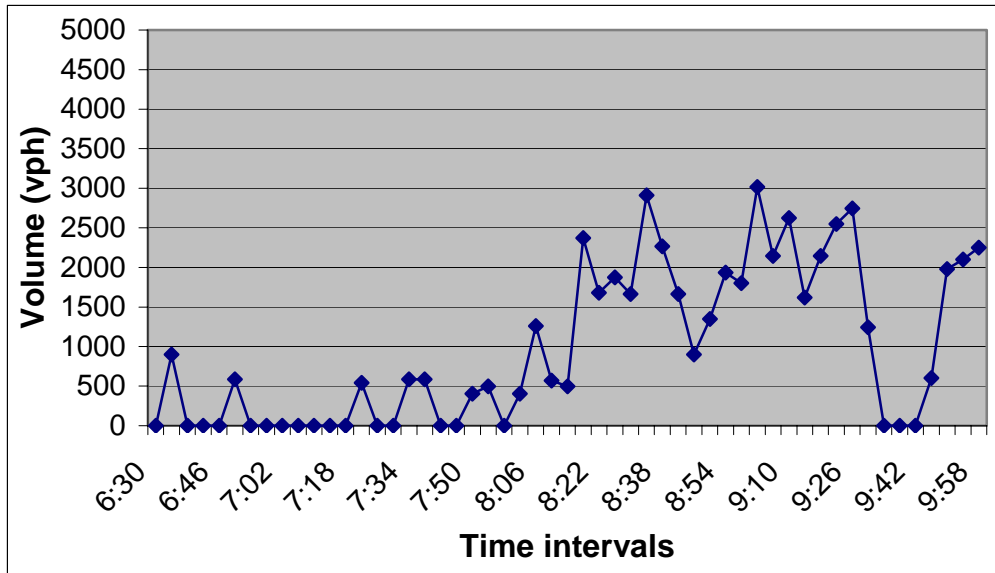
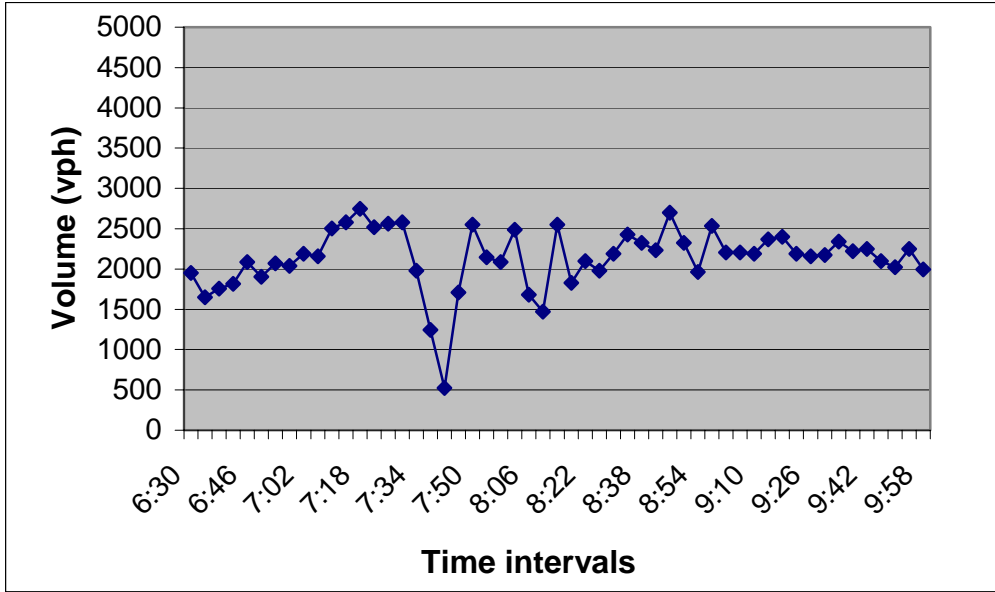
Note that the sensor at PCMS #1 did not function properly (see Figure 4-25). The volume distribution at PCMS #3 (see Figure 4-27) reflected stable and uncongested traffic conditions.

**Figure 0-25:** Volume distribution from Sensor #1 at PCMS #1 (AM, 12/04/2003)

**Figure 0-27:** Volume distribution from Sensor #3 at PCMS #3 (AM, 12/04/2003)

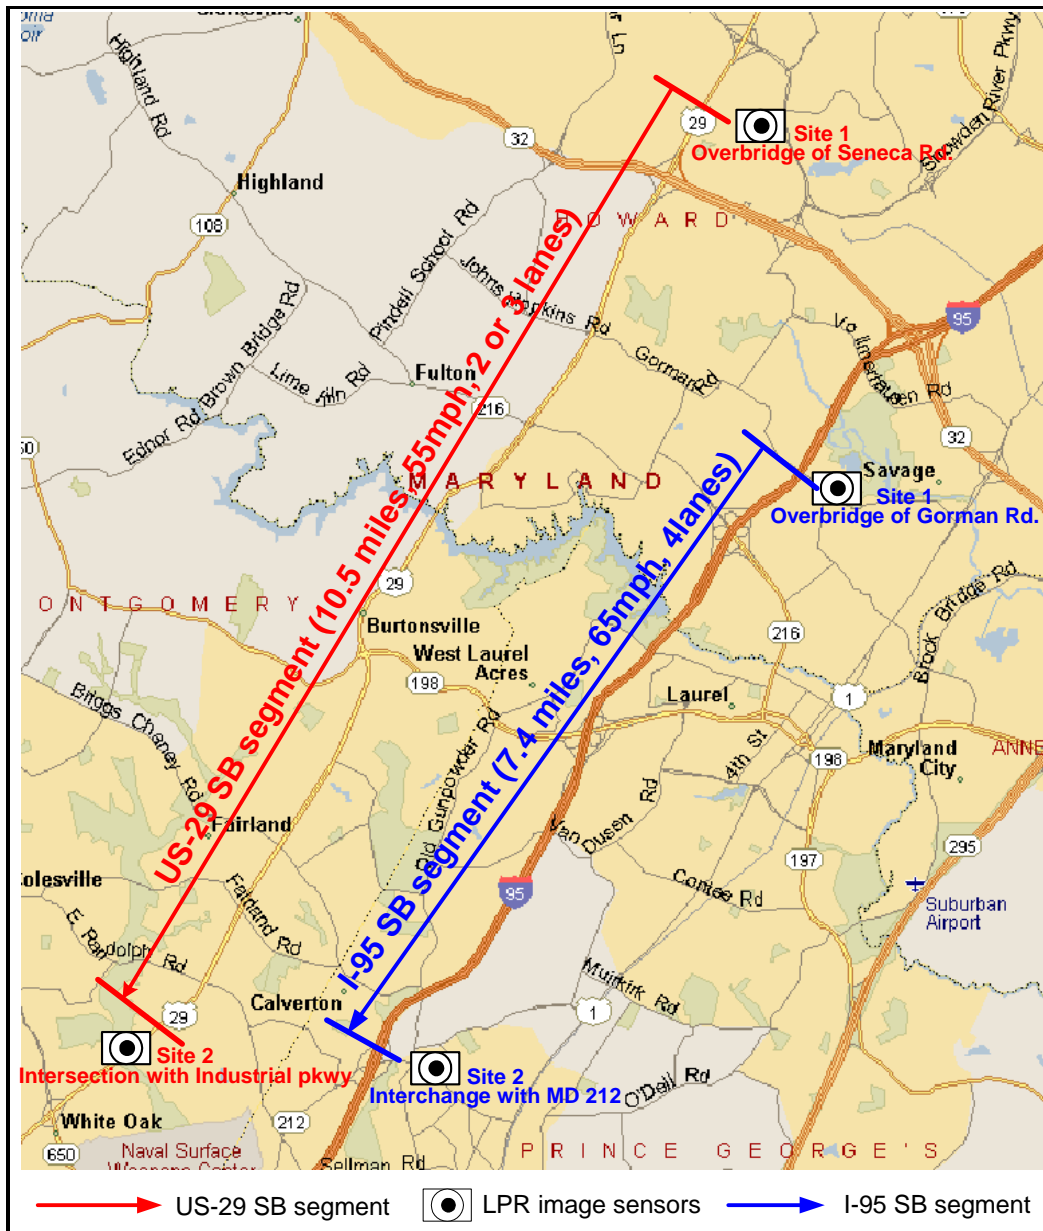
The main function of the license plate recognition (LPR) system is to identify the entry and exit times of vehicles traveling through a targeted highway segment (e.g., Figure 1-1), based on license plate images captured by the system. These images along with the associated data strings (i.e., time, date, and license plate number) are then encrypted and sent to a central processing computer for travel time estimation and prediction.

Figure 0-1: LPR deployment sites
