### RESEARCH REPORT

# EVALUATION OF INTELLIGENT TRANSPORTATION SYSTEM DEPLOYMENTS FOR WORK ZONE OPERATIONS

MD-05-SP208B4H  
FINAL REPORT

AUGUST 2005

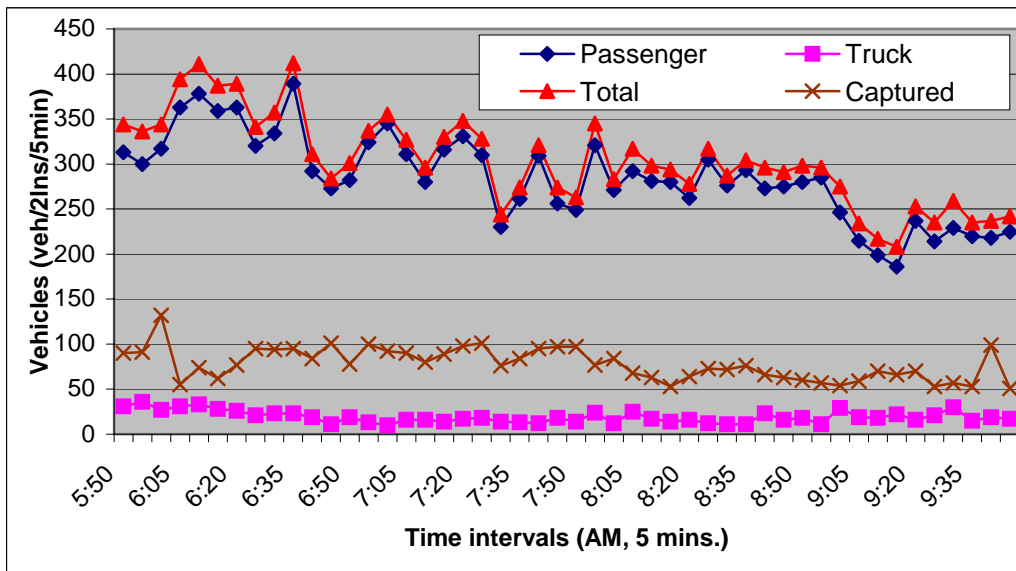
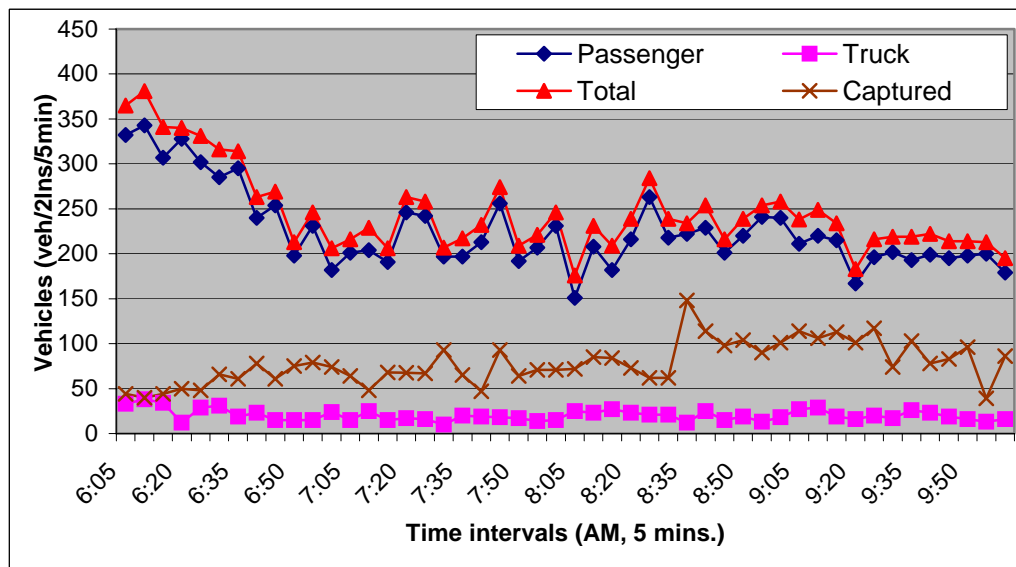
- As shown in Figure 4-1(b), it appears that the LPR system performs better at capturing the license plate images when traffic flows are moving at relatively lower speeds.

Figure 0-1(a): Comparison of actual volume and LPR captured images at Site 1 (11/18/04)

Figure 4-1(b): Comparison of actual volume and LPR captured images at Site 2 (11/18/04)
