RESEARCH REPORT

EVALUATION OF INTELLIGENT TRANSPORTATION SYSTEM DEPLOYMENTS FOR WORK ZONE OPERATIONS

UNIVERSITY OF MARYLAND, COLLEGE PARK

MD-05-SP208B4H
FINAL REPORT

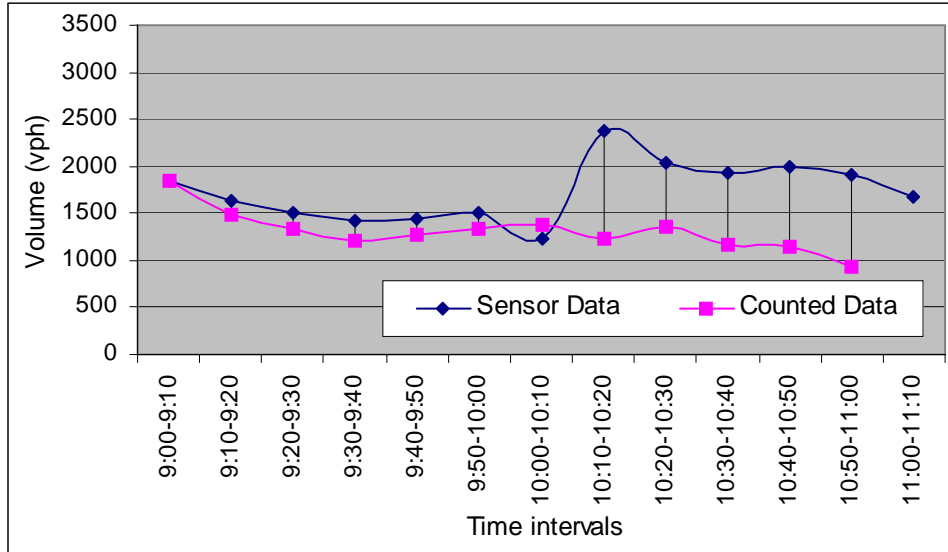
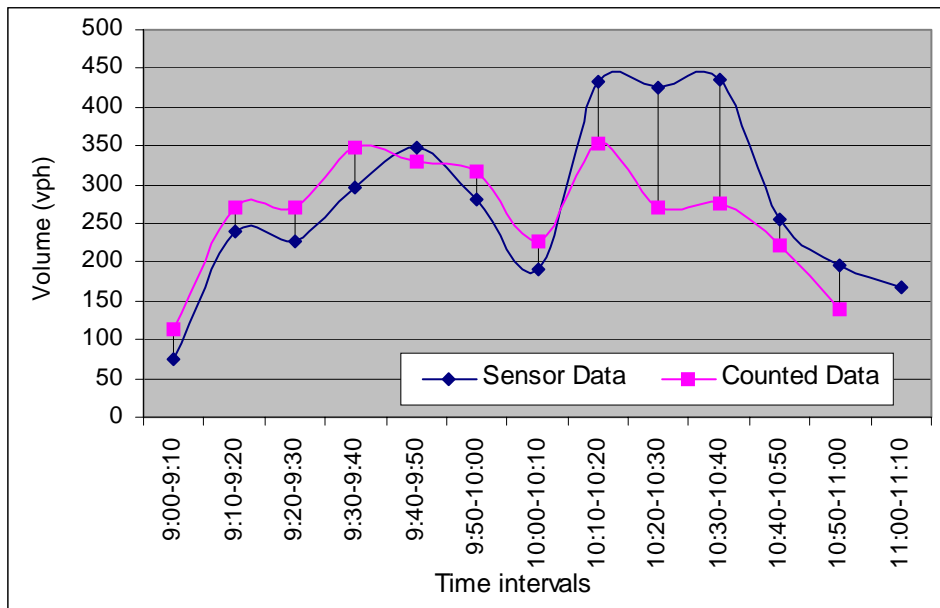
Figures 3-1 to 3-4 compare the sensor detected data and manually counted volumes for the open and closed lanes at the merge and middle points, respectively. The results clearly indicate that the volumes detected by sensors for both the open and closed lanes differ significantly from those counted directly from video tapes.

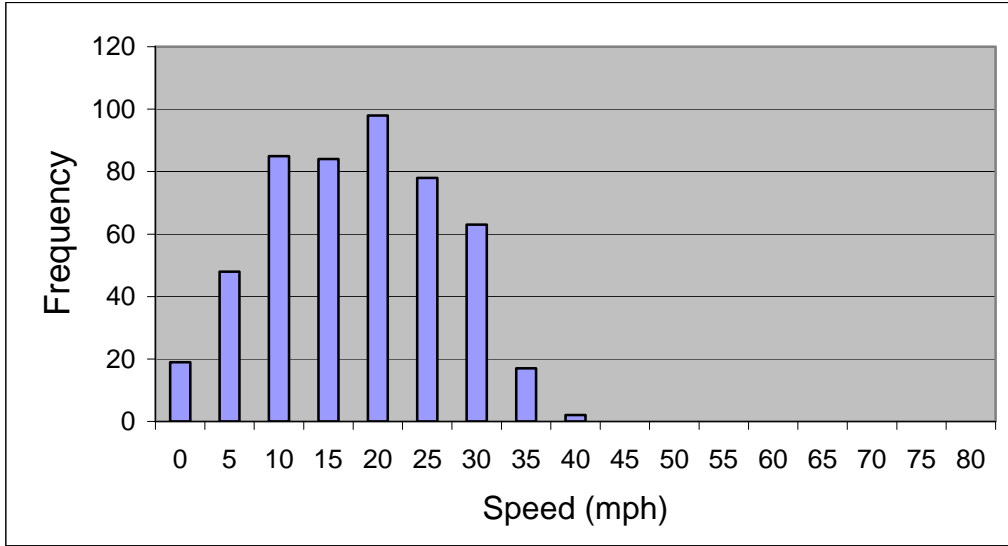
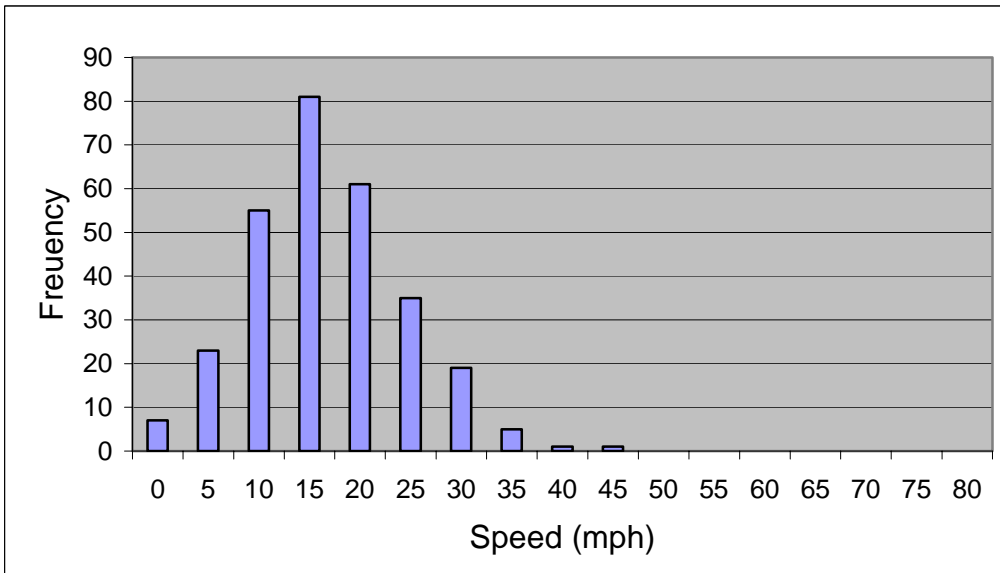
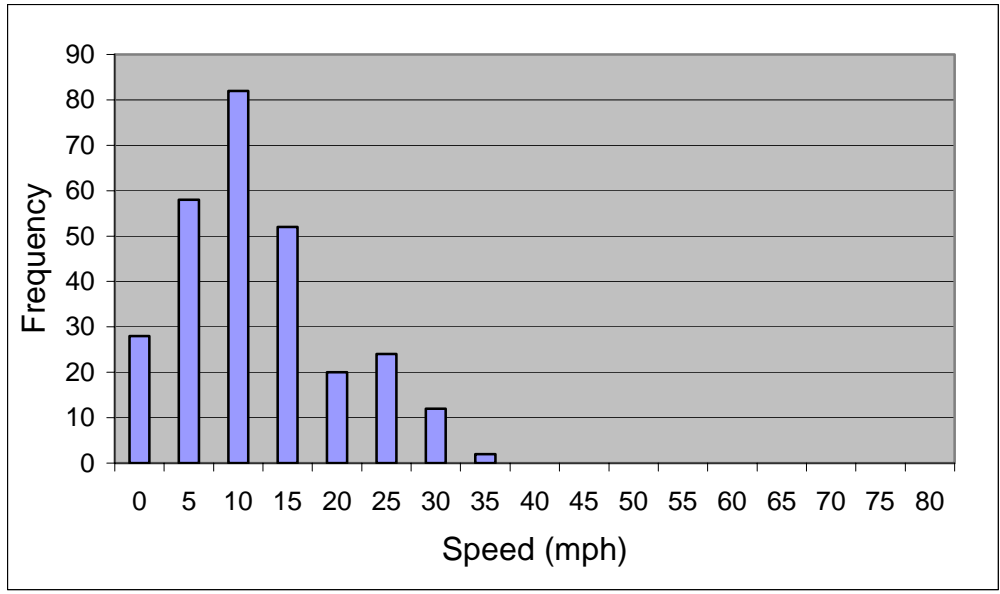
Figures 3-5 to 3-12, respectively, present the distributions of speed on the open and closed lanes under No-control and DLM control. It should be noted that the speed distributions on 10/10/2004 were measured with speed guns, and the distribution on all other dates were based on data measured by RTMS.

Based on the speed distributions measured under No-control (i.e., Figures 3-5 to 3-8) and field observations, it is apparent that the RTMS sensors under DLM control did not provide accurate speed measurements (Figures 3-9 to 3-12). For example, it is unlikely that some speeds have exceeded 100 mph on the open lane at the merge point (see Figure 3-10), during the DLM control period.

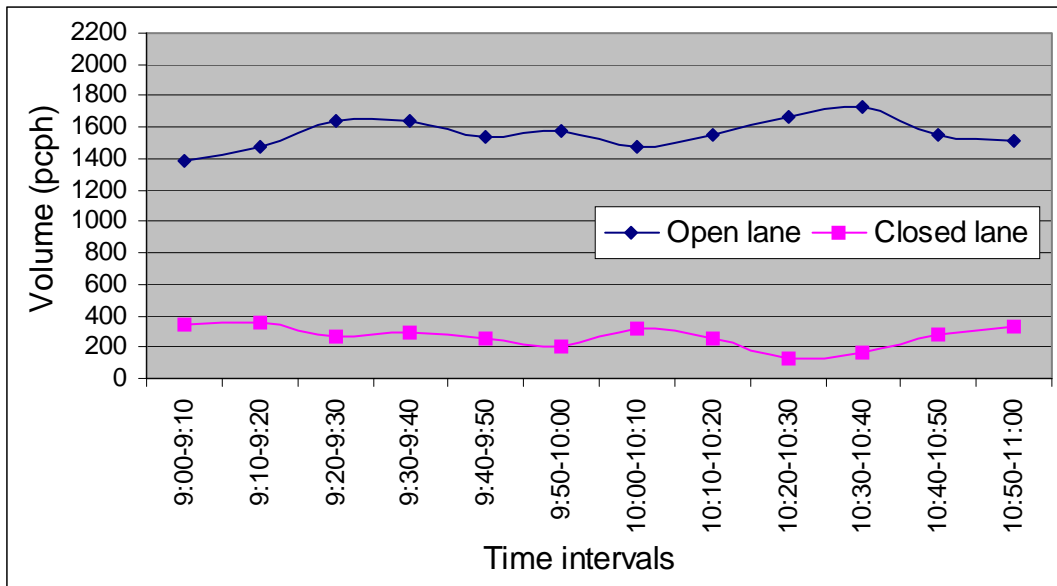
Figures 4-1 to 4-3 display the lane volume distributions at the merge, middle, and upstream points, respectively, under the No-control operation. Note that although volumes were nearly equal between both lanes at the upstream point (see Figure 4-3), many drivers began to use the open lane when they reached the middle point (see Figure 4-2). Also note that a large number of vehicles were observed on the open lane at the merge point (see Figure 4-1).

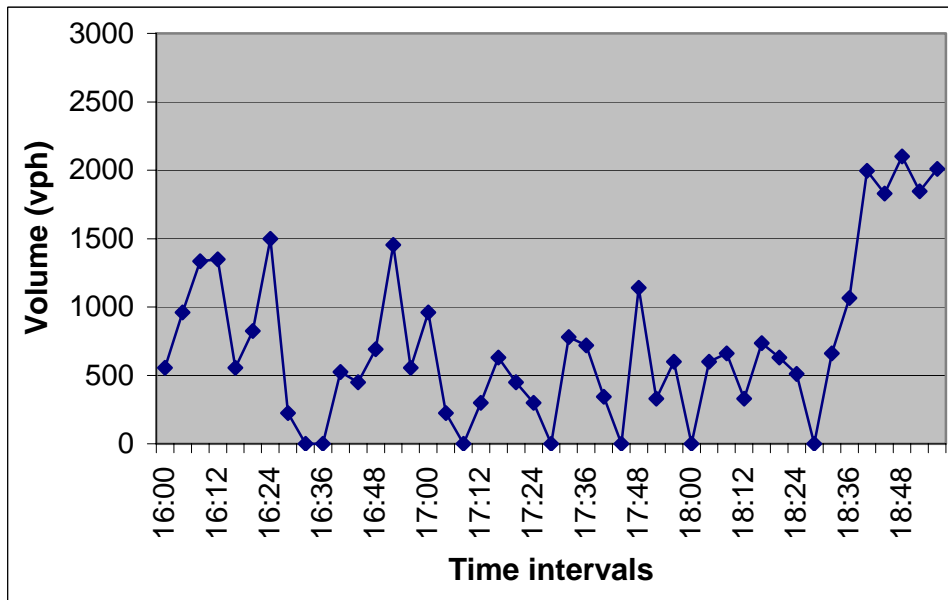
Based on the data obtained from all four sensors, Figures 4-13 to 4-16 present traffic flow patterns during the field survey period (4:00 p.m. ~ 7:00 p.m.). It should be noted that except at the location of the sensor trailer, traffic conditions were quite smooth on the targeted freeway segment. The predicted travel times by TIPS appear to mostly lie within an acceptable range under such traffic conditions.

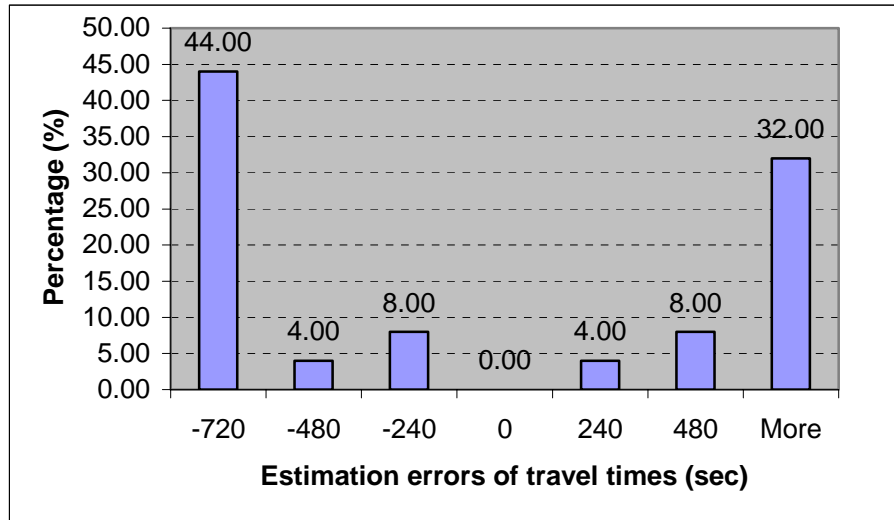
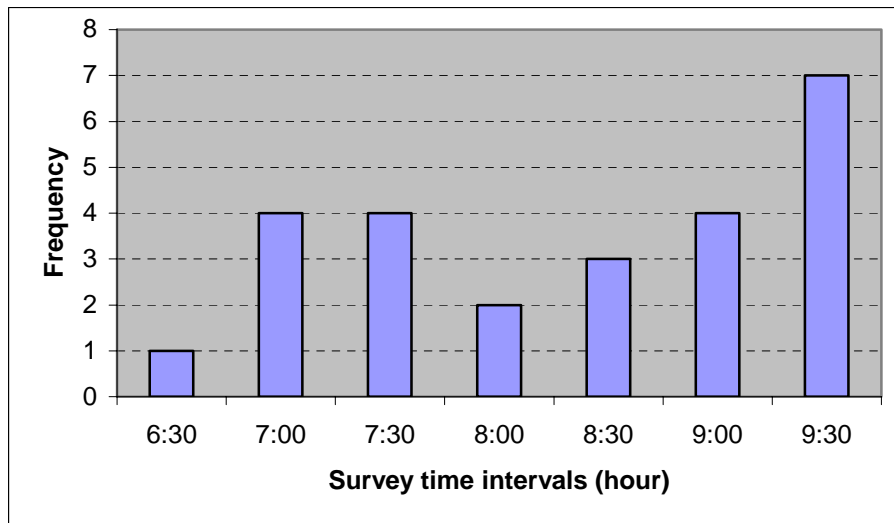
Figure 4-17 further shows the distribution of deviations from actual travel times displayed on PCMS #1. It should be noted that most of the incorrect travel times were displayed during the duration of Accident 2 and uncongested periods (Figure 4-18).

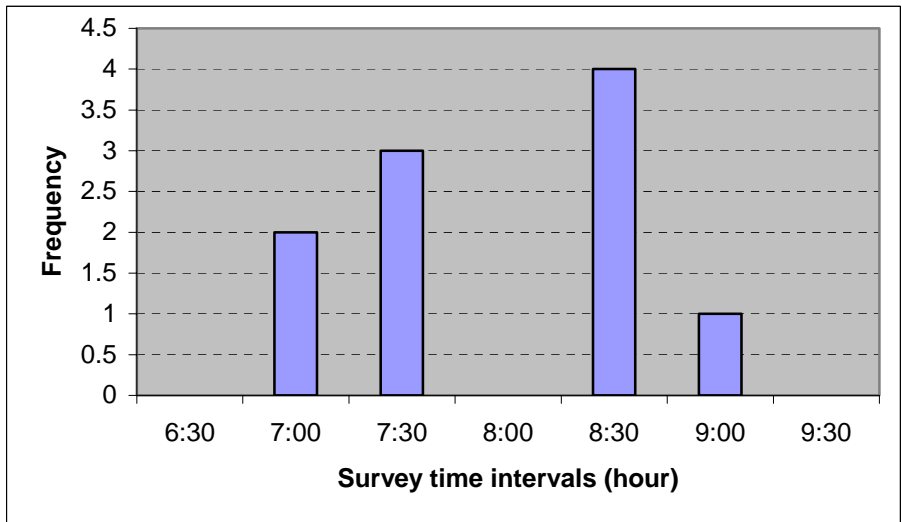
Additional analysis conducted for PCMS #2 also indicates that TIPS tends to underestimate travel time (see Figure 4-19), especially at the beginning and end of congestion periods (see Figure 4-20).

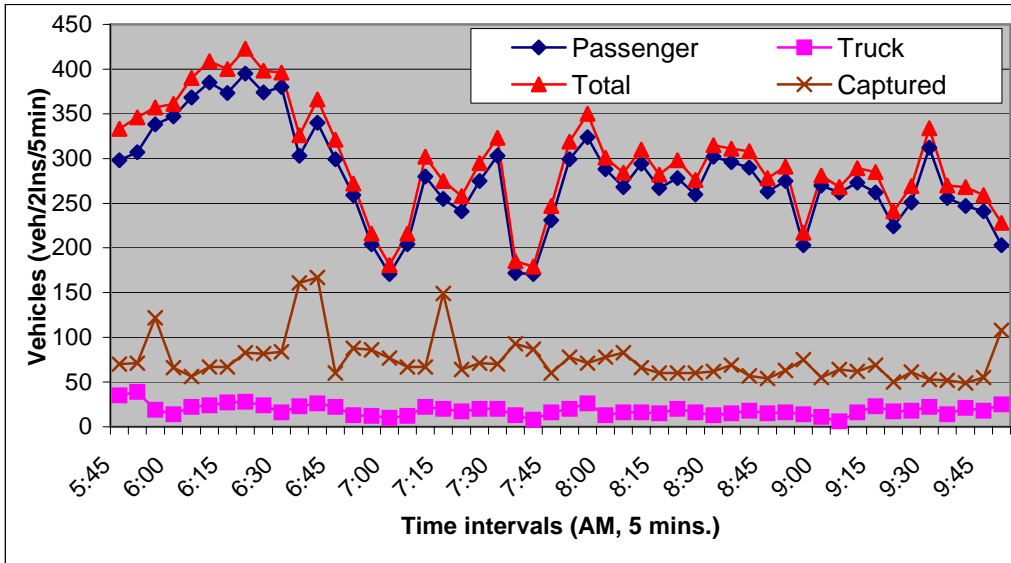
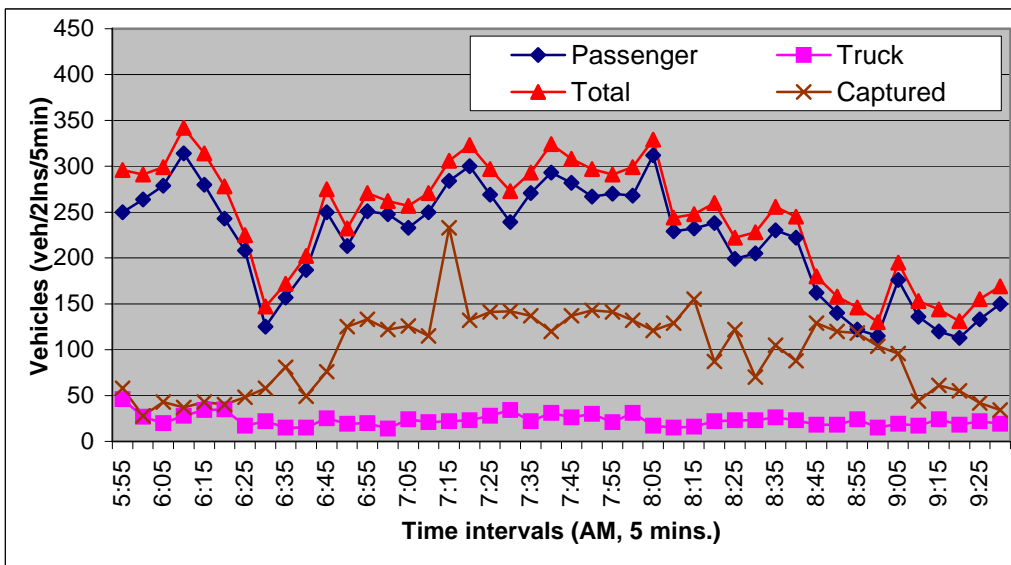
- As reflected in Figures 4-3 (a) and (b), the relatively high capture-ability (41.7 %) at Site 2 was due to the nearby accident, which resulted in slow traffic flow speed. In contrast, the capture-ability (26.1 %) at Site 1 under accident-free conditions was still relatively low, and similar to that on 11/18/04 (25.9 %) and 11/19/05 (25.9 %).
